From: John Brunini [jbrunini@brunini.com]
Sent: Tuesday, September 10, 2013 12:59 PM
To: Kato, Linda
Cc: Heimdal, Monica
Subject: BIP 40 - Restoration Plan for Impacts to Wetlands Associated with Williston Village RV Park
Attachments: Williston Village RV Resort Wetland Restoration Plan.pdf

WETLAND RESTORATION PLAN

Williston Village RV Resort
Section 24, T155N, R101W
Williams County, North Dakota
Project #4554

WETLAND RESTORATION PLAN DRAWINGS WILLISTON VILLAGE RV RESORT BRUNINI FIRM

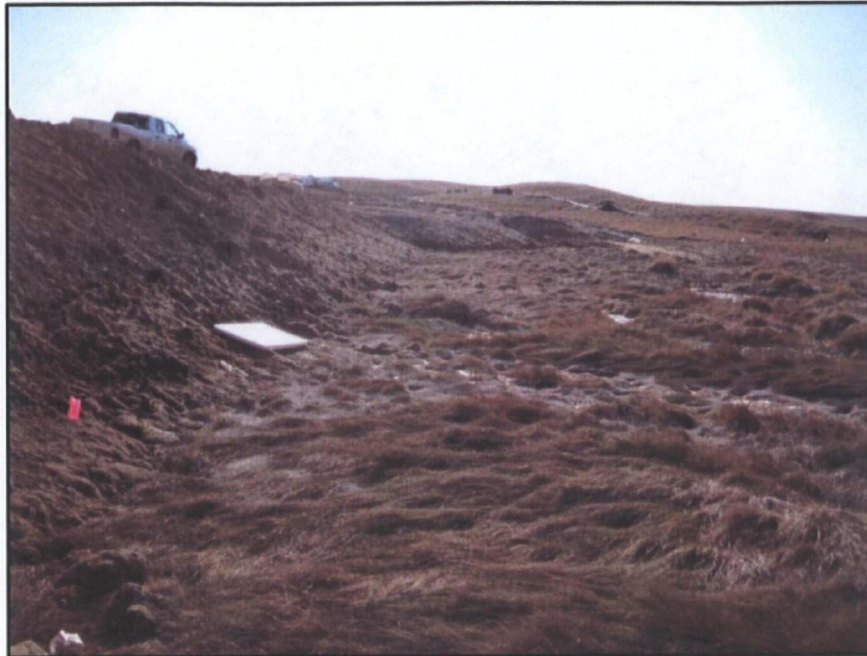
Photograph 1. View of the fill materials located within the downstream portion of the impacted wetland area.

Restoration activities will include removal of fill materials to the original elevations of the impacted wetland surface. The original surface elevations range from 1882.98 (upstream edge) to 1876.95 (downstream edge). Prior to impact, water flowed east through the wetland towards Camp Creek.

Approximately 148,000 cubic yards of material will be removed to restore the impacted wetland to its original ground surface. Conventional excavation equipment (dozers, scrapers, backhoes) will be used to remove fill materials. The use of conventional excavation equipment will ensure the restoration is completed quickly which will allow the restored site to quickly resume wetland functions. The excavation equipment will access the impacted wetland area from the south across upland areas. Excavated fill materials will be placed on the surrounding upland areas to the south and east of the impacted wetland area (Appendix A).

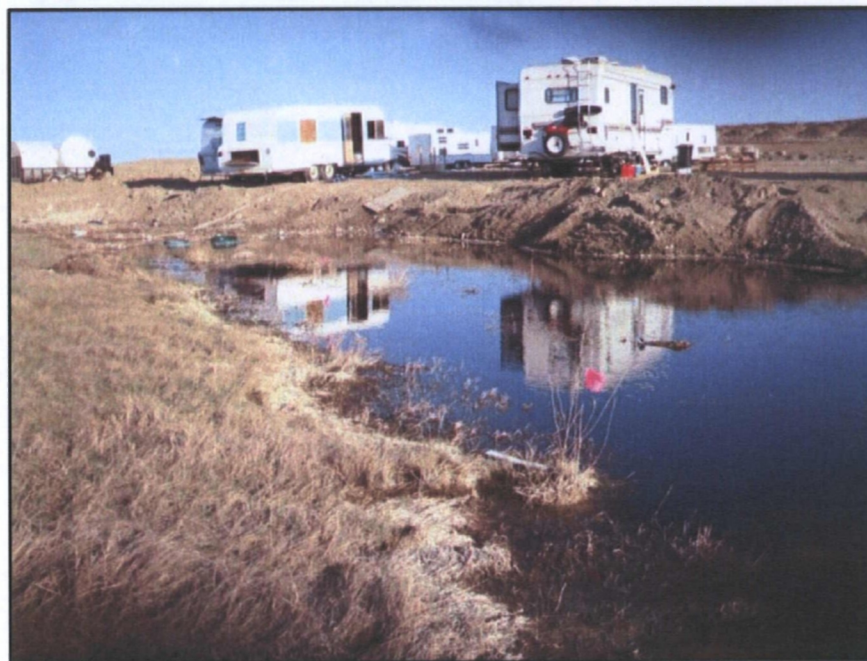
Photograph 2. View of upstream edge of the impacted wetland area. Surface water accumulated in the upstream portion due to the fill materials.

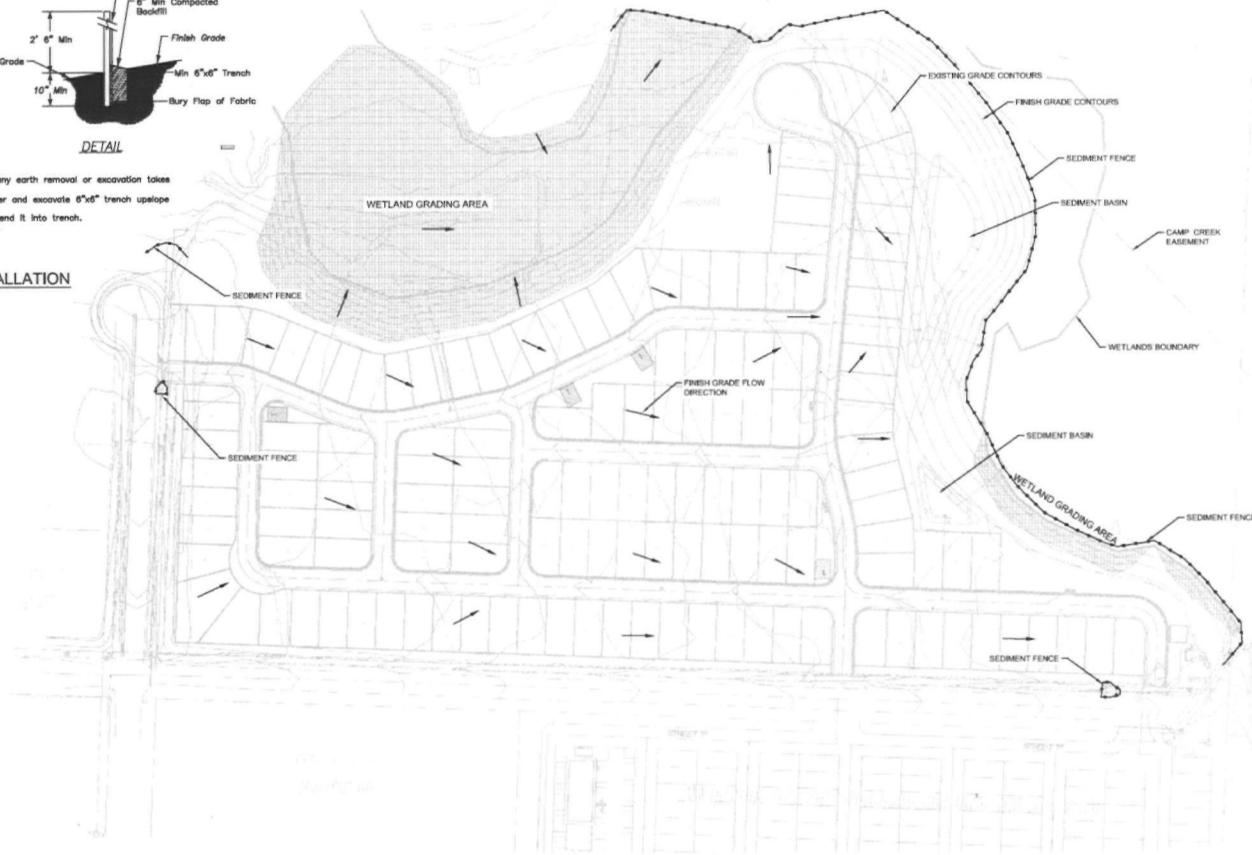
1. ALL DISTURBED AREA TO BE HYDROSEEDING UPON COMPLETION OF FINAL GRADING OF THE SITE AREA.
2. ALL TOPSOIL OR NATIVE MATERIAL PILES MUST BE LOCATED 200 FEET FROM ANY SURFACE WATER.
3. ALL RIPRAP WILL BE PLACED WITHIN 24 HOURS OF PLACEMENT OF THE PIPES.
4. SEDIMENT BASINS SHALL BE IN PLACE PRIOR TO PLACEMENT OF THE STORM SEWER SYSTEM.
5. ROUGH GRADING OF THE SITE WILL DIVERT ALL STORM WATER TO THE SEDIMENT BASINS SHOWN.
